EXAMPLE REPORT OF PROPERTY CONDITION ASSESSMENT

< Address >
< CITY, STATE >

Subject: **Example Report of Property Condition Assessment**

HCI Project No. <ProjNo >

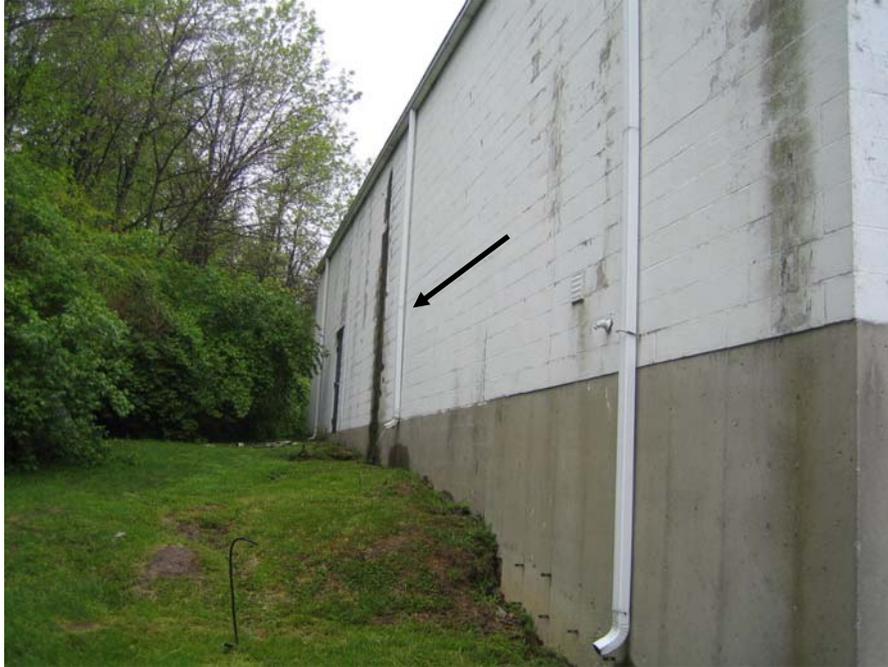
PHOTOGRAPH 3

View of south side of building looking west. Note wall deterioration at previous downspout location.

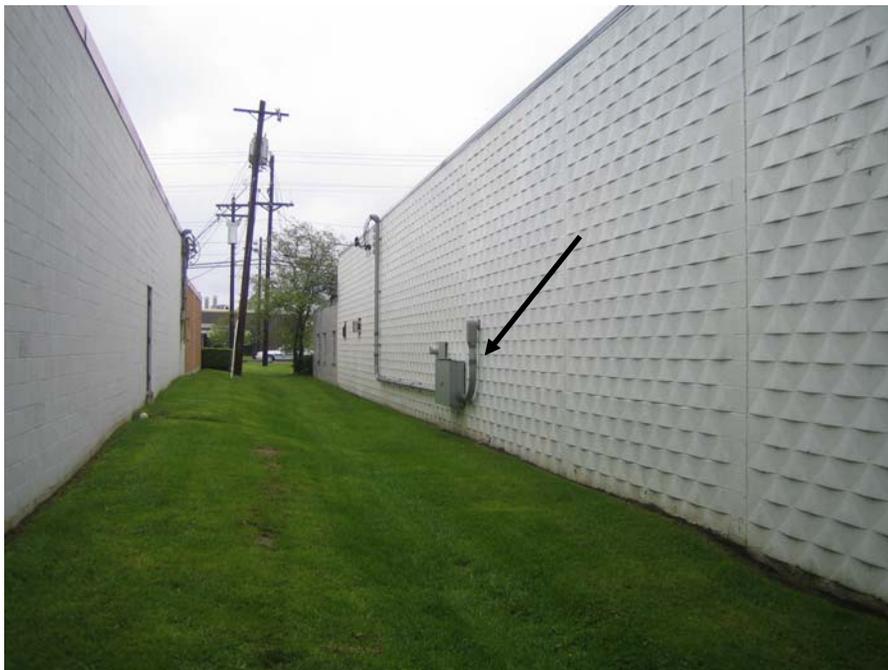
PHOTOGRAPH 4

View of west side of building looking north. Note electrical service (600-Amp) which is not currently used.

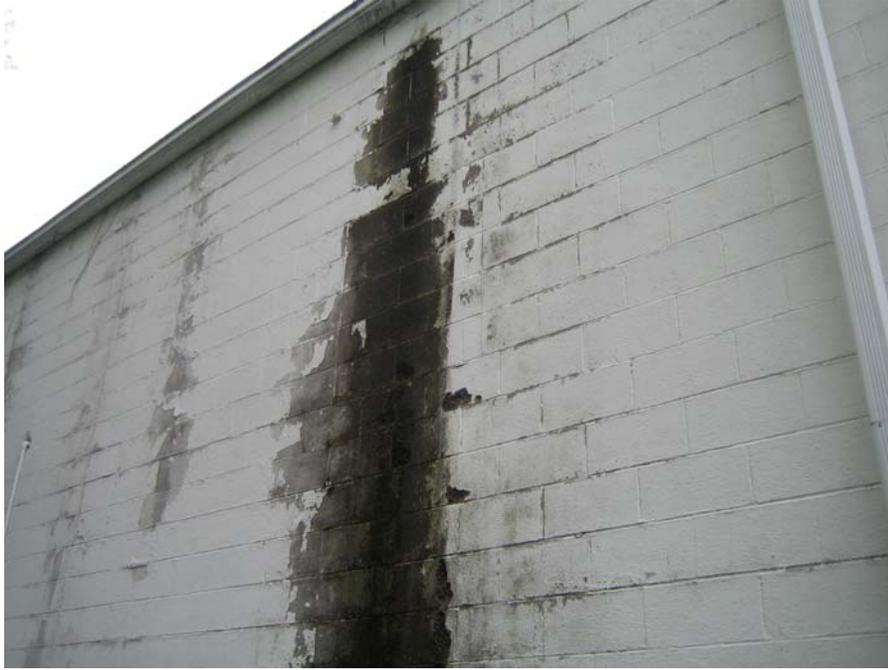
PHOTOGRAPH 5

Wall deterioration from previously existing downspout on south side of building.

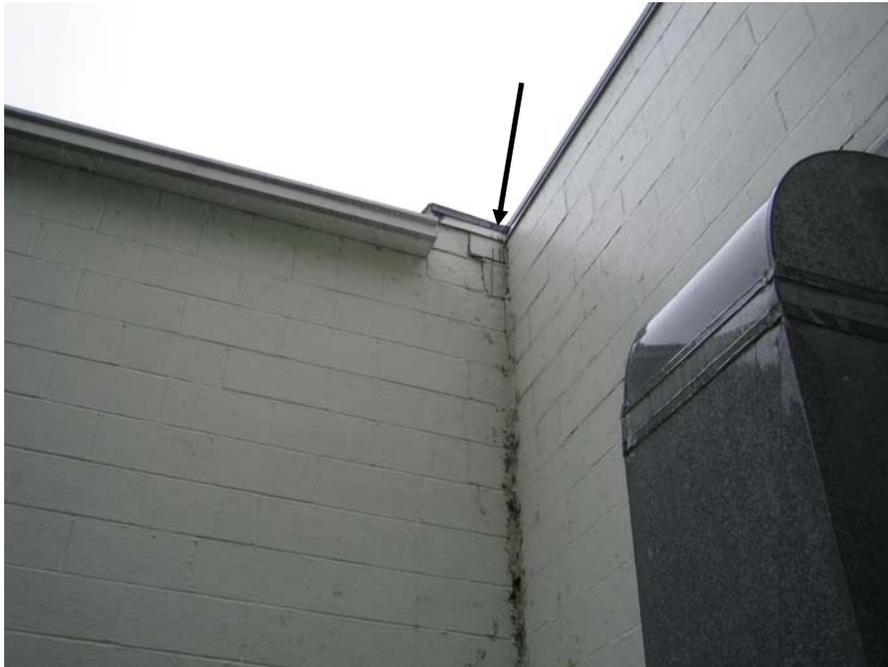
PHOTOGRAPH 6

Building framing consists of masonry block walls with what appears to be masonry columns at nominal 12 feet centers along the perimeter and at some interior walls. The interior walls are most likely the result of building expansions. Interior framing includes nominal 6-inch diameter tubular steel interior columns. Roof framing consists of open-web steel joists bearing on what appears to be steel "I" beams spanning wall columns, however, the majority of this construction was obscured by masonry block. As previously indicated, HCI noted some wall and/or façade cracks at the northwest corner and south sides of the building that could be associated with foundation movement.

Masonry wall cracks at south side of building.

- **HCI recommends that the walls be repaired and crack monitoring gauges be installed to determine if movement is on-going. For the purposes of this report we have assumed that the masonry block wall and façade can be repaired by tuck-pointing. Actual repairs will depend on the movement (if any) information obtained over time from crack monitoring gauges. For the purposes of this report we have assumed foundation under-pinning will be required at the northwest corner. The cost of this work is presented on Table 1 as an "Immediate Repair Item."**

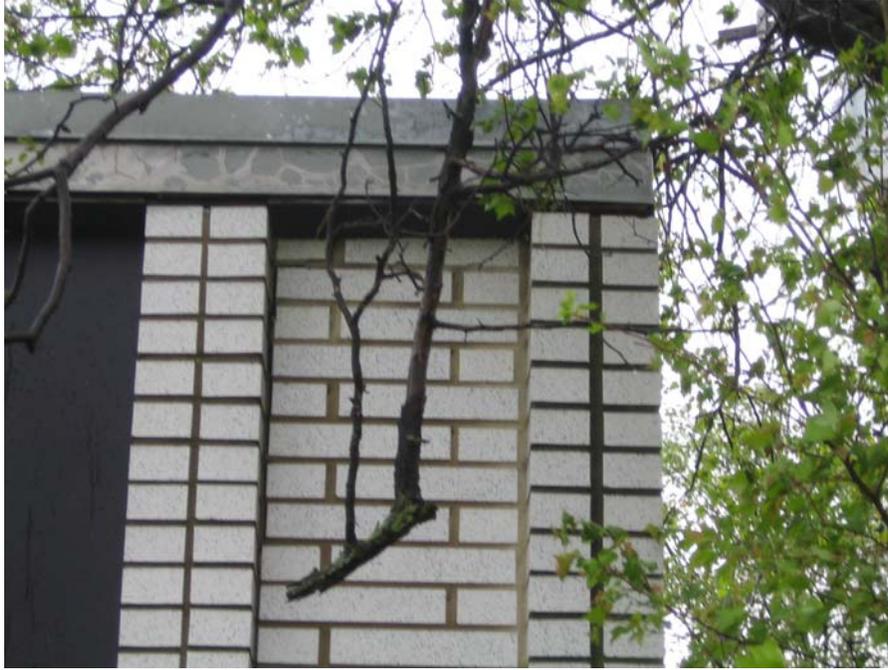
PHOTOGRAPH 7

Façade cracks at northwest corner of building.

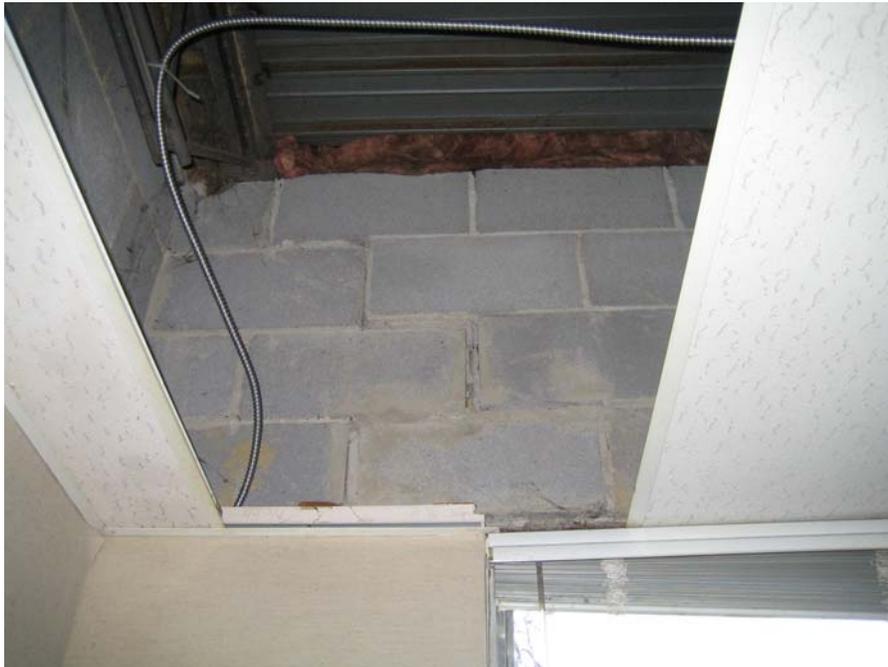
PHOTOGRAPH 8

- **As indicated in the sections that follow some foundation movement may have occurred and could possibly still be occurring at these wall crack locations. HCI recommends that wall crack monitoring gauges be installed to document any building movement. For the purposes of this report we have assumed**

that foundation underpinning will be required in the northwest corner of the building.

Interior view of masonry wall cracks present at northwest corner of building.

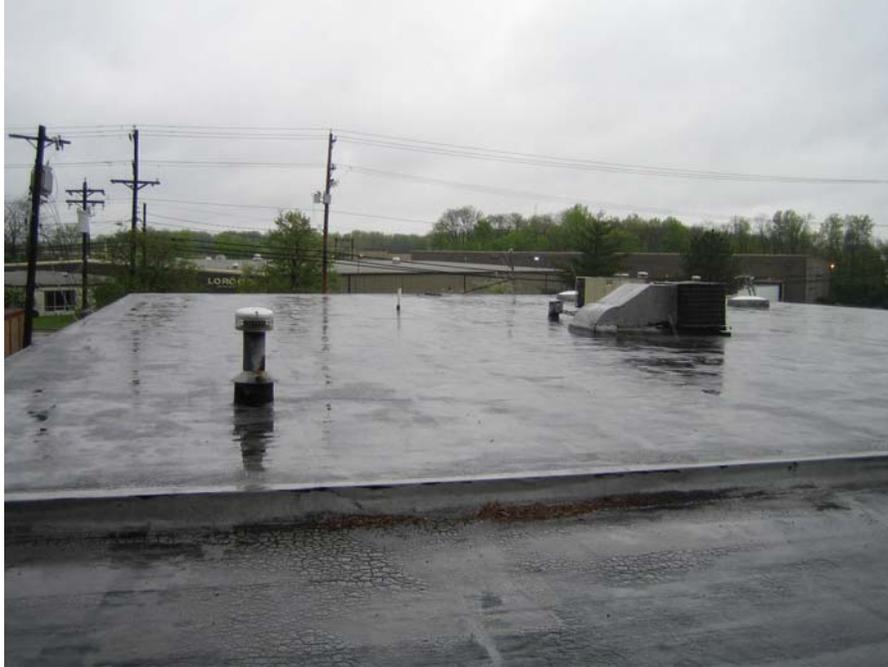
PHOTOGRAPH 9

Overview of west side of building roof looking north.

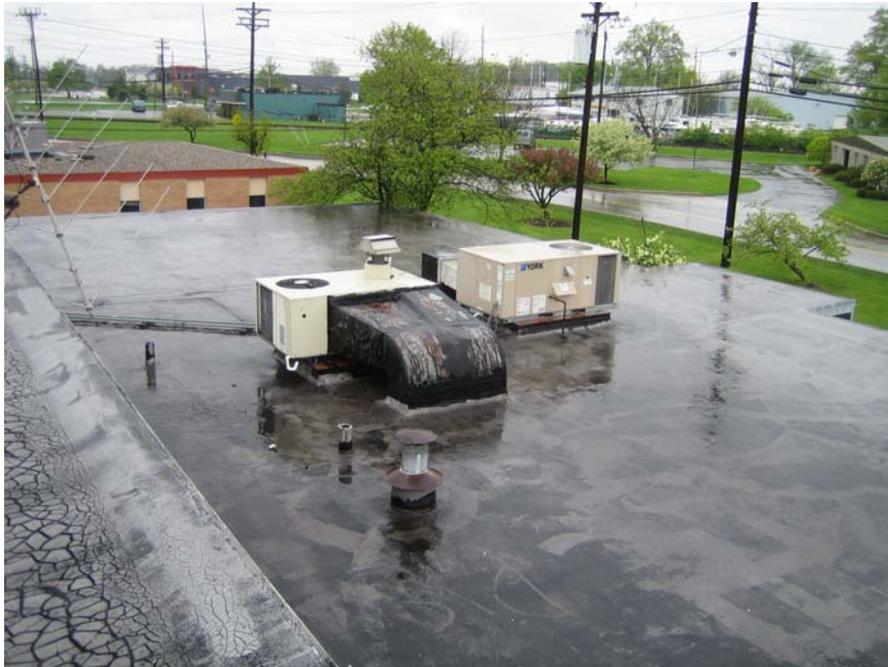
PHOTOGRAPH 10

Overview of office (north) roof and rooftop HVAC units looking northwest.

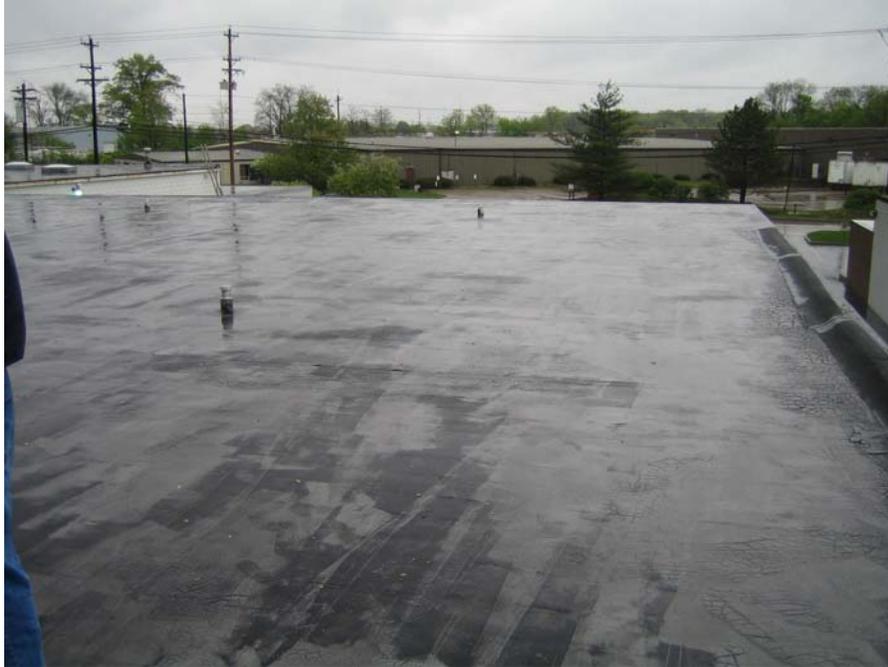
PHOTOGRAPH 11

Roof Membrane-Existing roofing consists of what appears to be a smooth-surfaced asphalt built-up roof system with an aluminized type coating. We noted that there were moisture relief vents present at the east roof section and overlapping edge flashing along the perimeter of all roof sections indicating that there are most likely additional roof(s) below the exposed roof membrane.

Overview of east section of building looking north. Note vents most likely for moisture relief.

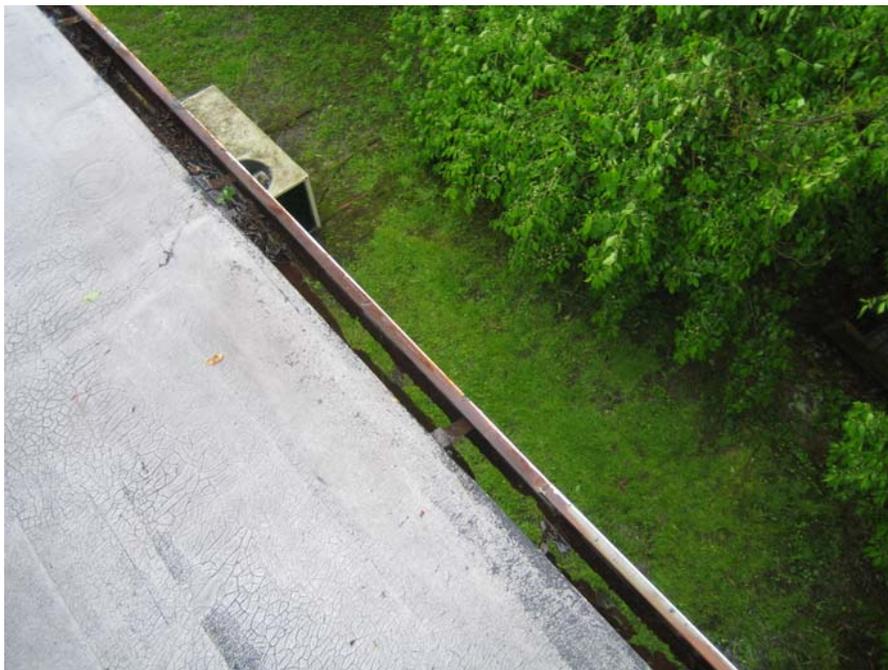
PHOTOGRAPH 12

Roof Drainage-The central and south sections of the west building section drains to gutters and downspouts located on the south side of south roof section. The east roof section also drains to gutters and downspouts on the south side. The north (office area) of the west building area drains to a scupper and downspout located at the southeast corner. There was ponding water noted along the south building edges and at the southeast corner scupper of the north (office area) roof section. In addition to the ponding on the north (office area) roof of the west building section there is substantial silt accumulation. The gutter on the south side of the east building section has been recently replaced. The gutter on the south side of the west building section is extensively deteriorated.

Deteriorated gutter at south side of west building section.

- **HCI recommends that the silt accumulation be removed as a part of routine maintenance and the roof drainage be corrected as a part of the roof replacement work by a system of insulation crickets and if necessary, interior drains. HCI also recommends that the gutter and downspout at the west building section be replaced as an Immediate Item.**

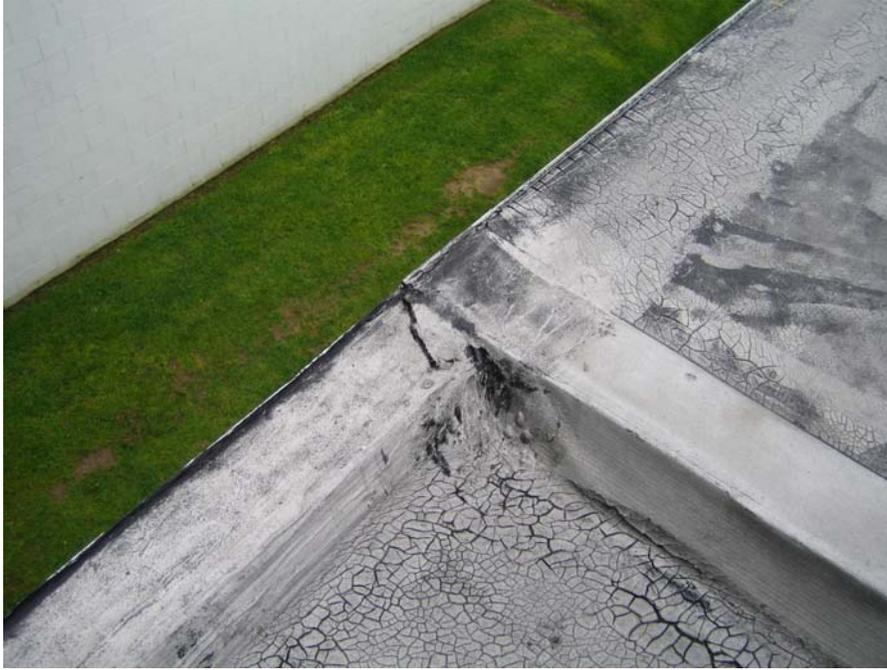
PHOTOGRAPH 13

Roof Terminations and Penetrations-The roof areas terminate at gutter and raised edge flashing or at the building perimeters and at expansion joints or counter flashing separating the building sections. Some deterioration of the edge flashing was noted at the west side of the central roof section. The roof areas are penetrated by electrical, plumbing and exhaust vents. There are several curbs present within the roof associated with rooftop HVAC equipment. In addition, there are three nominal 2.5 feet by 4 feet skylights present on the west central roof. The skylights appeared substantially deteriorated exhibiting cracking of the plastic domes and sealant.

Deteriorated flashing present at south side of west building section.

- **HCI recommends isolated flashing deterioration be completed as a part of routine maintenance and that the roofs be budgeted for replacement by Year 5. Since two roof systems are most likely currently present removal of the**

existing roofs will be required prior to installation of the new roof system including skylights. The cost of this work is presented on Table 1.

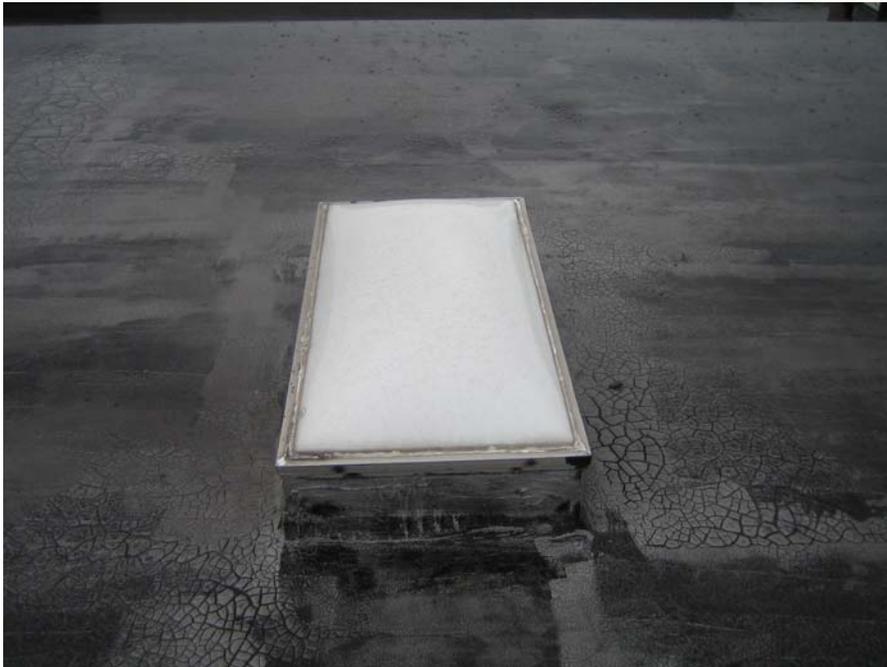
PHOTOGRAPH 14

Skylight on west building section.

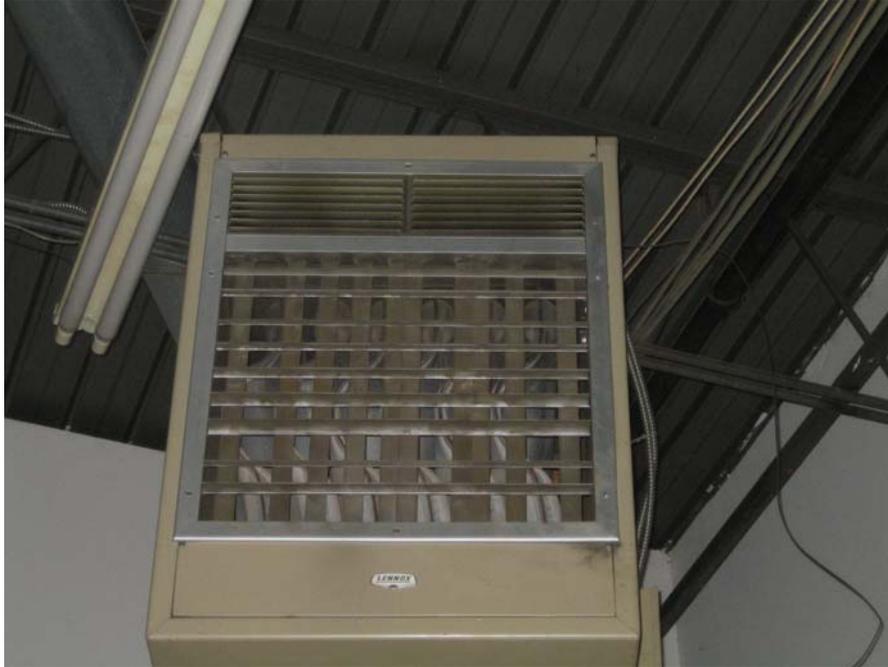
PHOTOGRAPH 15

Gas-fired unit heaters suspended from roof framing present in southern portion of west building section.

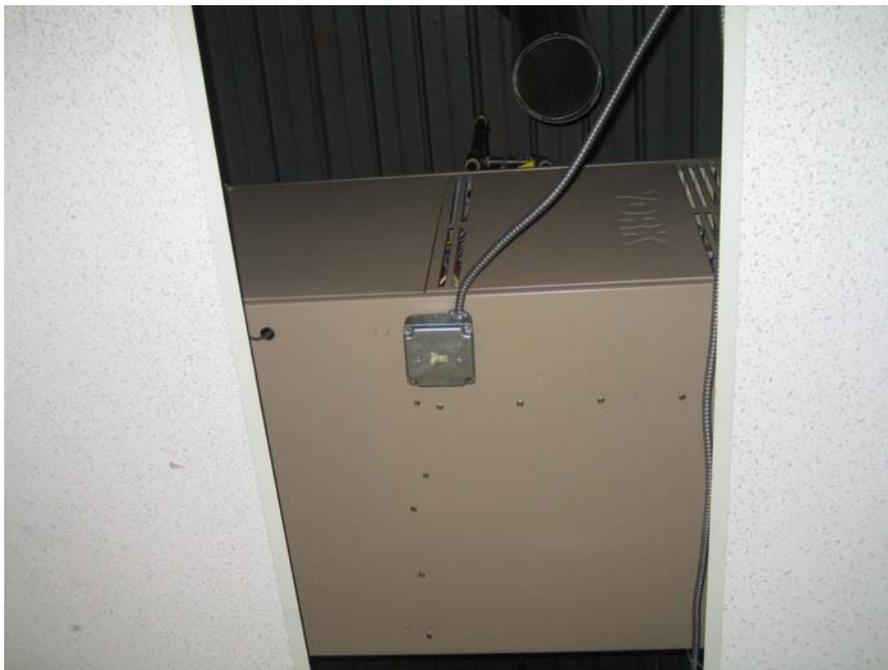
PHOTOGRAPH 16

Unit heater present above suspended ceiling tile.

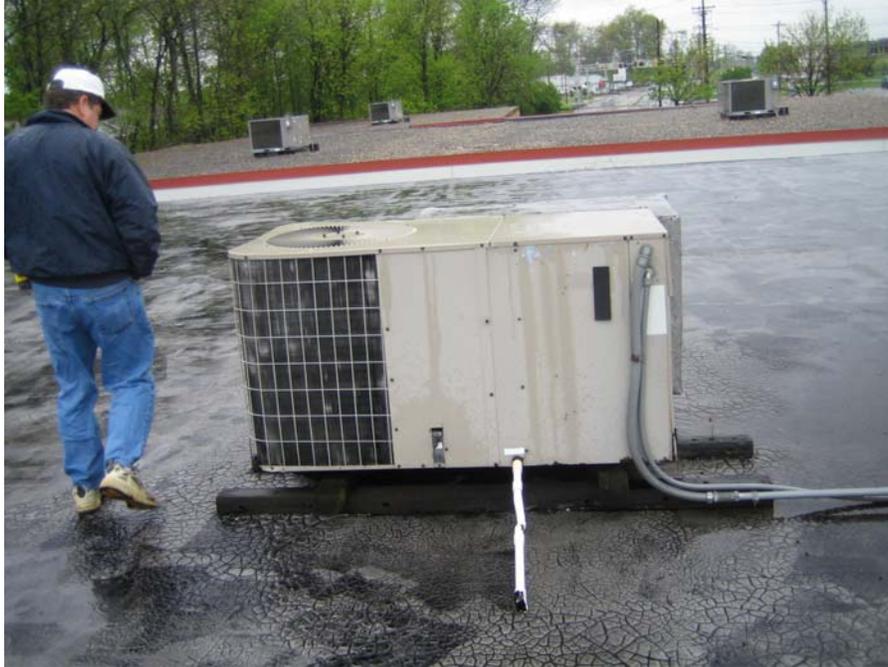
PHOTOGRAPH 17

Rooftop HVAC unit present on south side of west roof section.

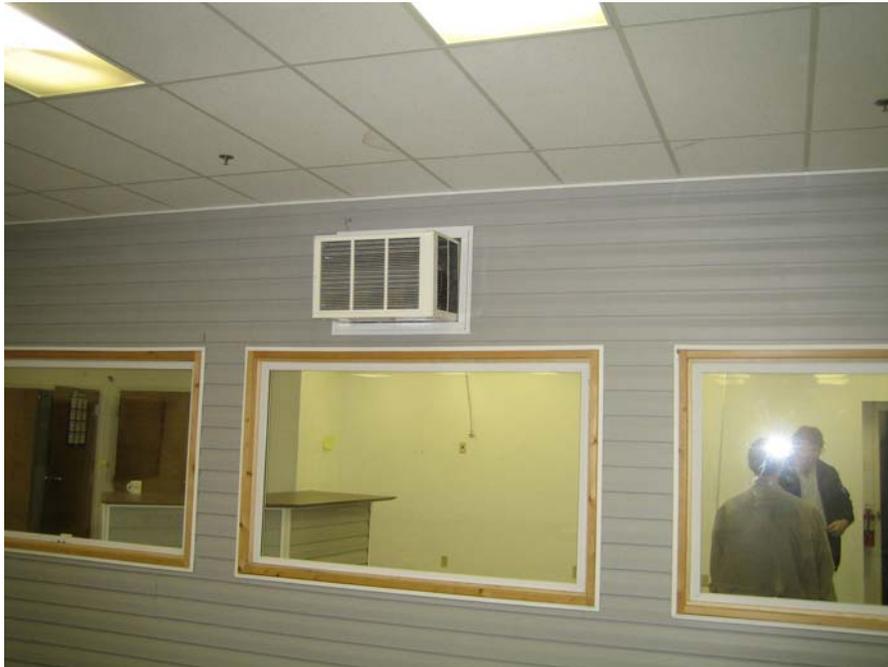
PHOTOGRAPH 18

Thru-wall HVAC unit present within building.

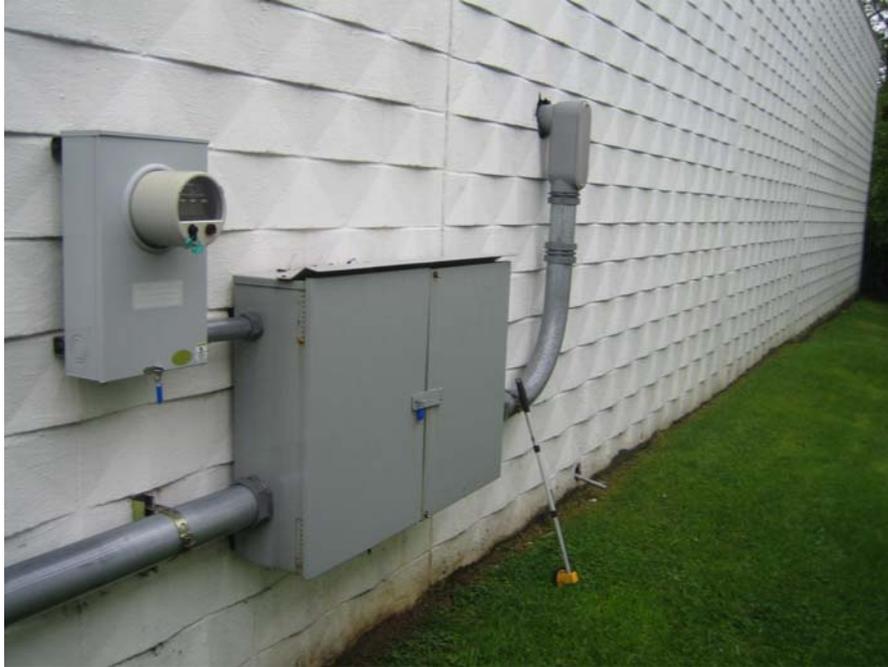
PHOTOGRAPH 19

Exterior view of 600-Amp service present on west side of building not currently in use.

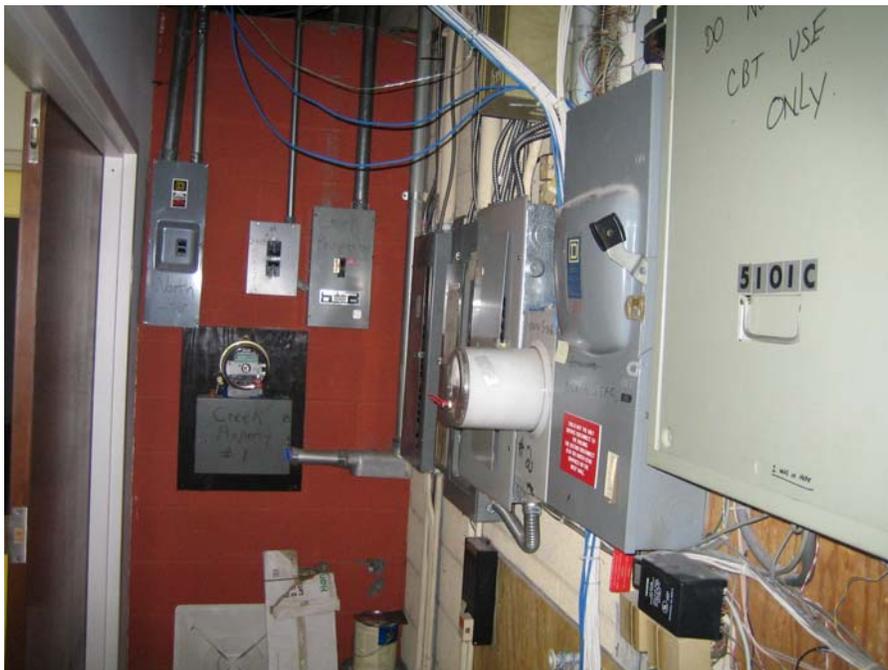
PHOTOGRAPH 20

Electrical service present on south side of office area. Note two electrical meters present.

- **HCI recommends that a detailed assessment of the electrical service and connections be performed. The cost of this work is presented as an Immediate Cost Item of Table 1.**

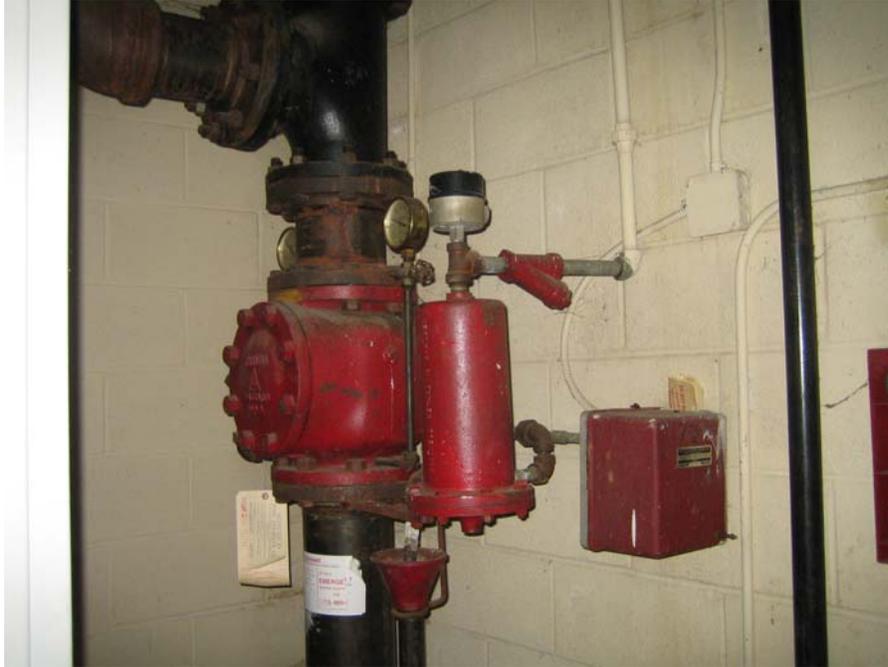
PHOTOGRAPH 21

Sprinkler riser present in enclosure on east side of building.

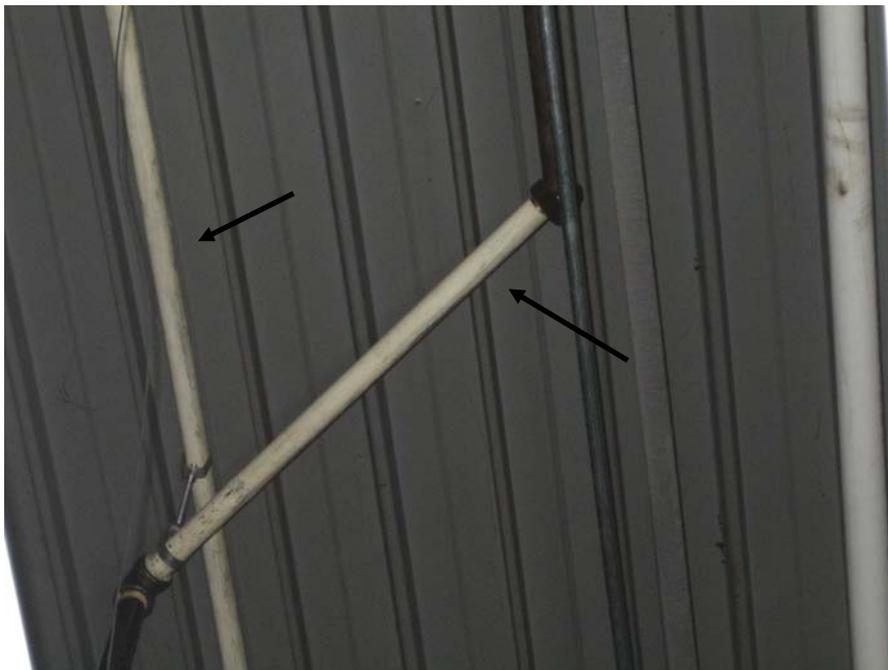
PHOTOGRAPH 22

Piping-Plumbing piping within the building was observed to be copper domestic water supply and ductile iron sprinkler system supply. Waste piping was observed to be cast iron. Gas piping is ductile iron. We did note some PVC piping in the return air plenum of the west building section that appeared to be associated with a supply line and a sprinkler line repair. Although a code review was not included in our scope of services,

we believe the use of PVC material in a return air plenum would not comply with most codes. Further, use of PVC piping for supply line or sprinkler lines would also most likely not comply with plumbing and life safety code requirements.

View of what appears to be sprinkler line repair completed with PVC pipe present on west side of building (right arrow). Note PVC pipe used for hanger support between open-web joists (left arrow)

- **HCI recommends that PVC supply piping be removed from the return air plenum and be replaced with copper or ductile iron piping as appropriate. The cost of this work is included as an “Immediate Repair Item” in Table 1.**

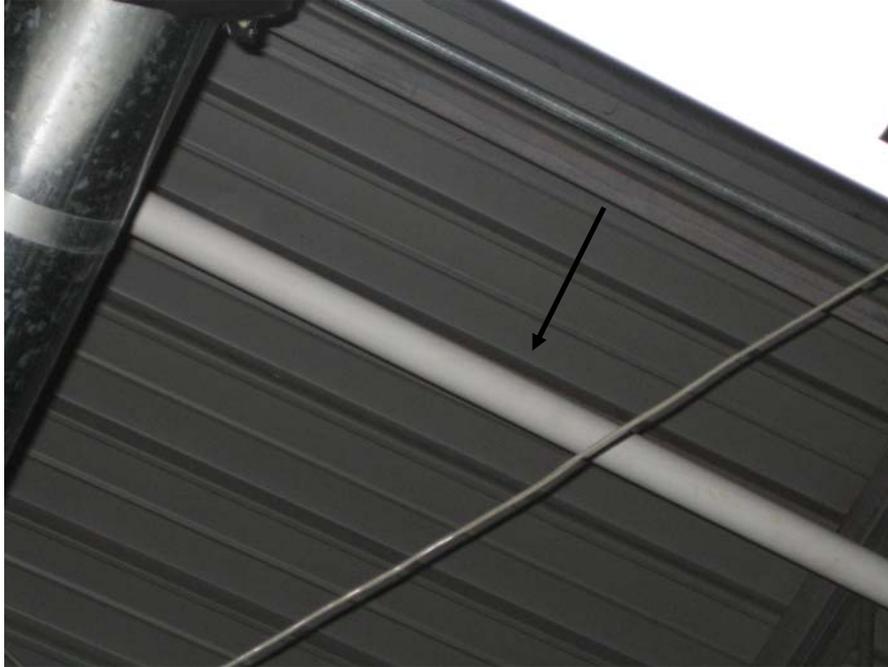
PHOTOGRAPH 23

- **As previously indicated, HCI noted that there is PVC piping present in the west central building section. Although code assessment was not a part of our services, we note that most codes do not allow PVC materials within a return air plenum.**

PVC plumbing pipe present in return air space at west side of building.

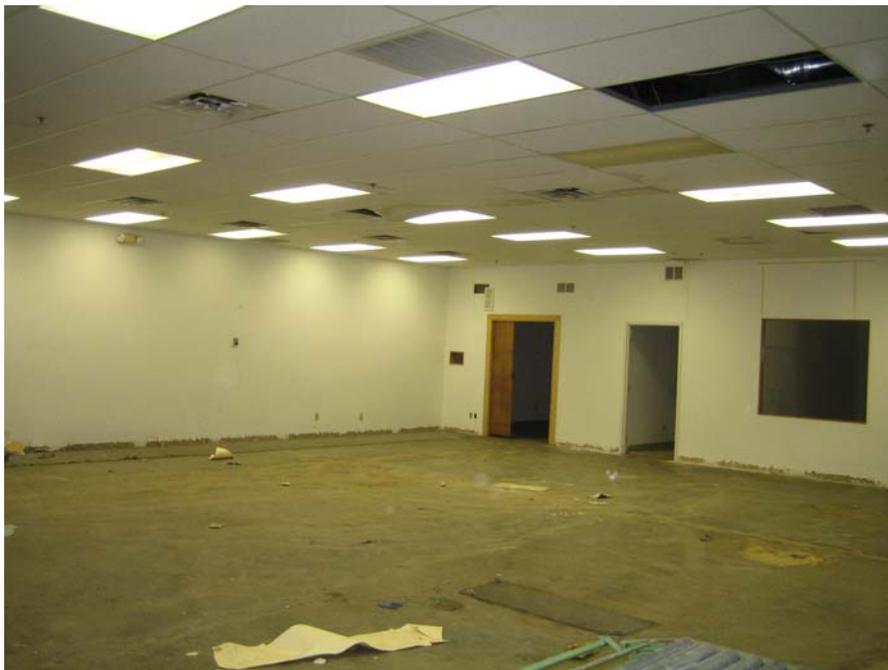
PHOTOGRAPH 24

View of west building section interior.

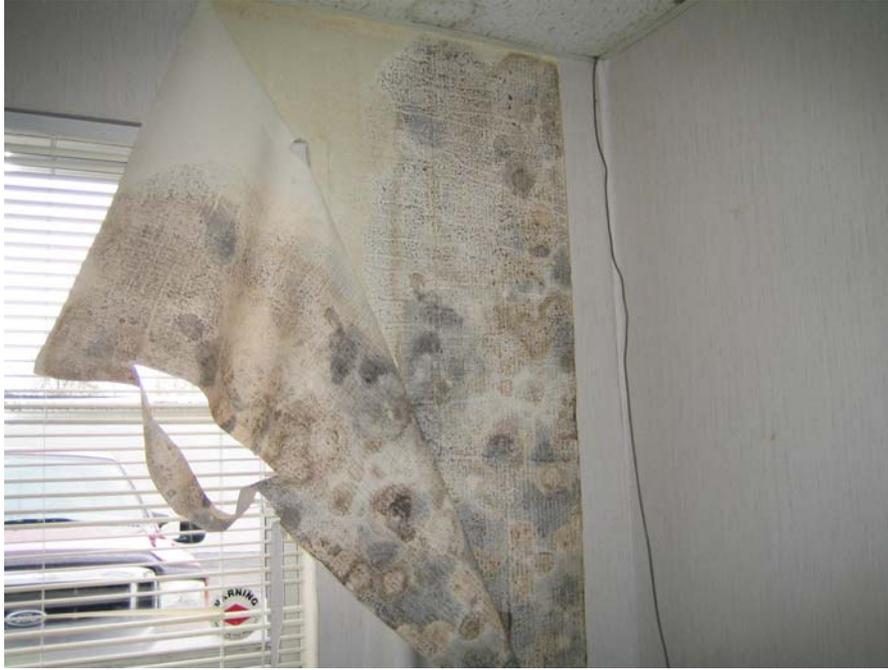
PHOTOGRAPH 25

The office area interior finishes typically consist of painted gypsum wallboard and wall paper. The wallboard installed over wood framing without insulation or a vapor barrier between the exterior walls and partition walls. The lower half of restroom walls is covered with yellow colored ceramic tile. There was significant evidence of mold along the east wall of the office area. This mold was present on the inside surface of the vinyl wall paper and on the exterior paper surface of the gypsum wallboard. Exploration behind the wallboard was not performed. Mold was not noted on any interior partition wall or on the west or north exterior wall gypsum wall board surfaces. There were also some partition walls in the remainder of the building constructed of painted gypsum wall board. In general gypsum wallboard partitions were in poor condition.

Apparent mold on drywall and inside surface of vinyl wallpaper at east side of office.

- **HCI recommends that all gypsum wall board be explored for mold and this material be removed with special consideration to potential contamination of other areas of the building. The cost of this work is included as an Immediate Item in Table 1.**

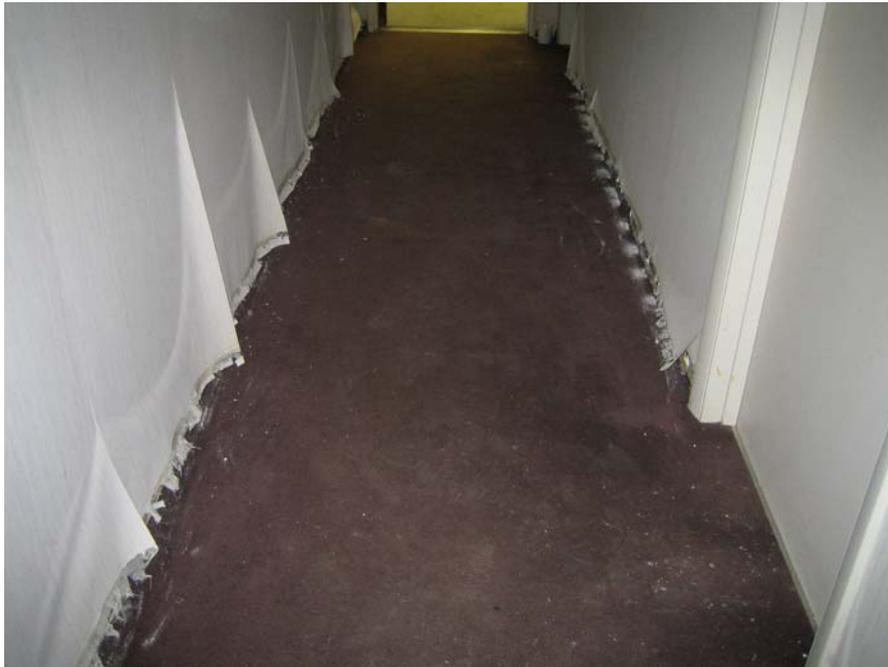
PHOTOGRAPH 26

View of office hallway in west building section. Note peeled wallpaper.

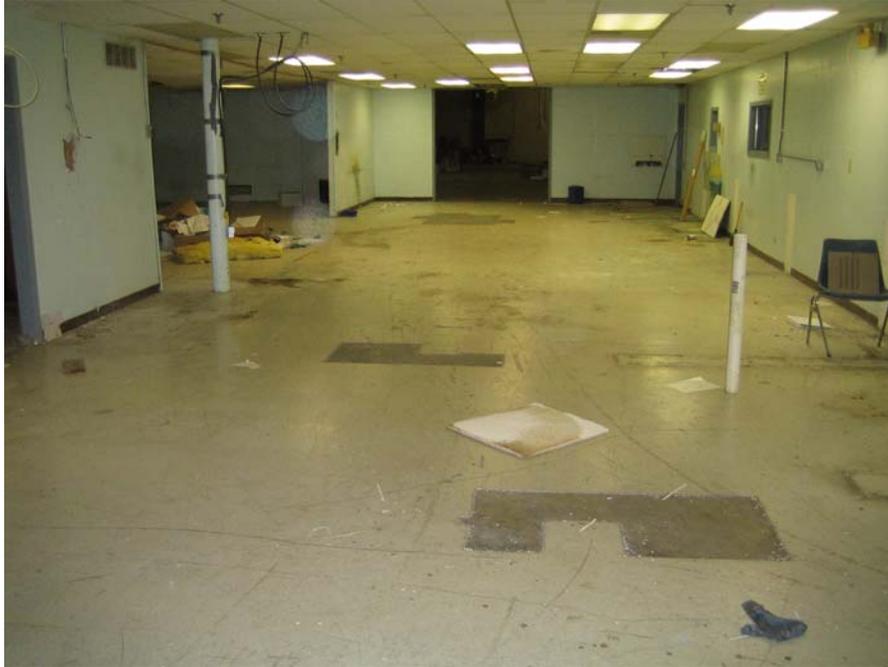
PHOTOGRAPH 27

Interior view of eat building section looking west.

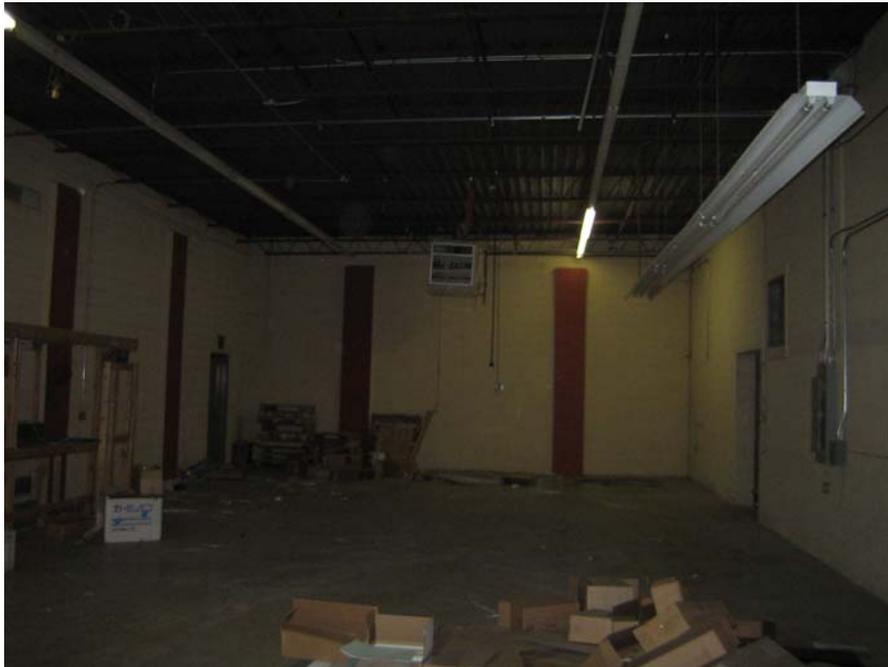
PHOTOGRAPH 28

Interior view of south end of west building section looking west.

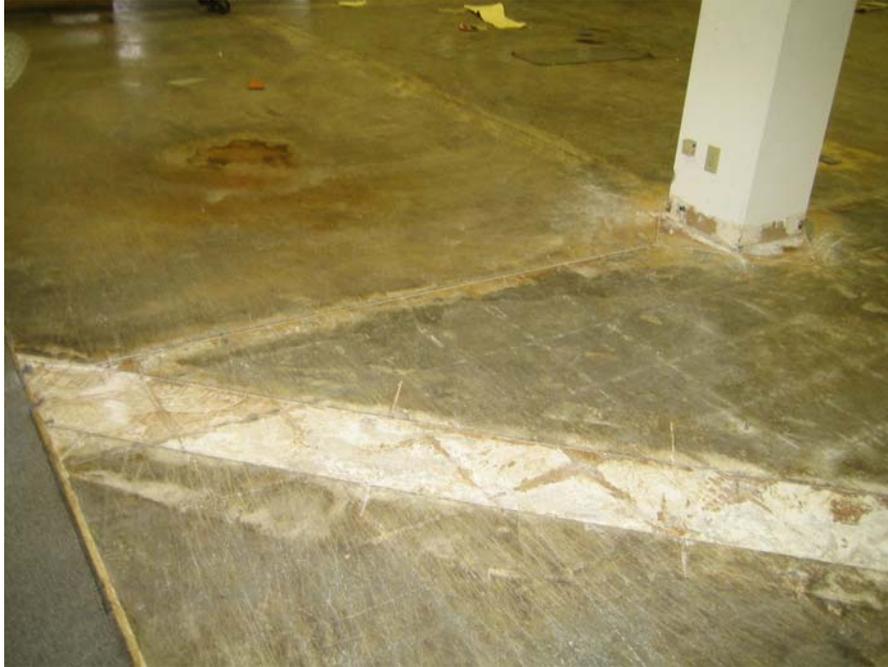
Floor System-The floor system consists of a Portland cement concrete slab-on-grade. The floor slab was covered with carpeting in the office area and vinyl tile in the majority of the east building section obscuring any cracks that may be present. We noted substantial floor cracking and spalling especially near the loading dock bay doors in the central and south portions of the west building section. We also noted repairs most likely associated with a water line installation running diagonally through the west center building section.

PHOTOGRAPH 29
Plumbing trench repair in west building section slab.

- **HCI recommends that the existing cracks be repaired and a topping slab be installed. For the purposes of this report, we have assumed that the topping slab will be required in all but the office building area. The cost of this work is included on Table 1.**

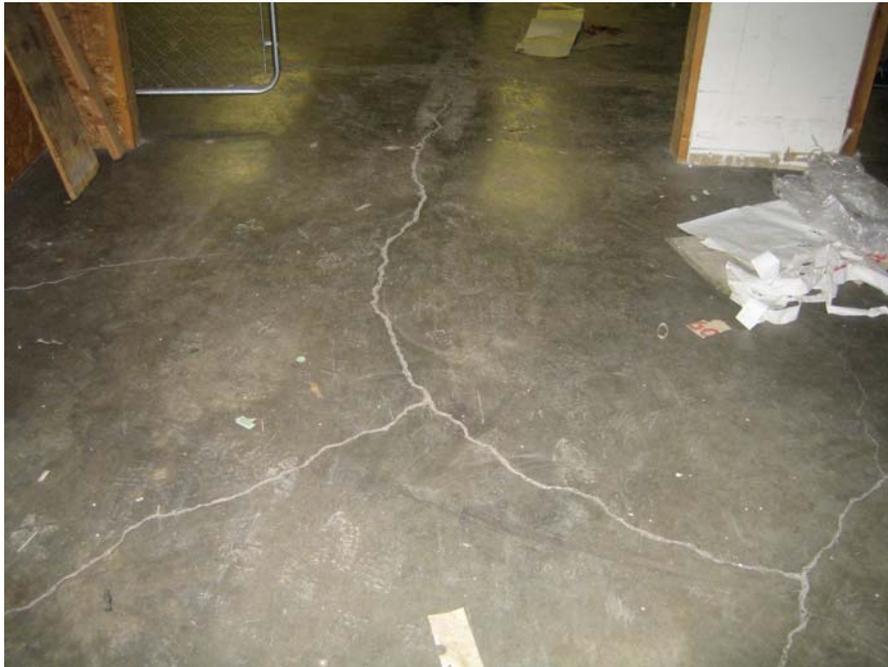
PHOTOGRAPH 30
Slab cracks at west building section.
