REPORT OF ROOF CONDITION STUDY

YOUR FACILITY Your Facilities Location

Subject: **Report of Roof Condition Study**
Project Identification
[Project Location]
HCI Project No. [HCI Project No.]

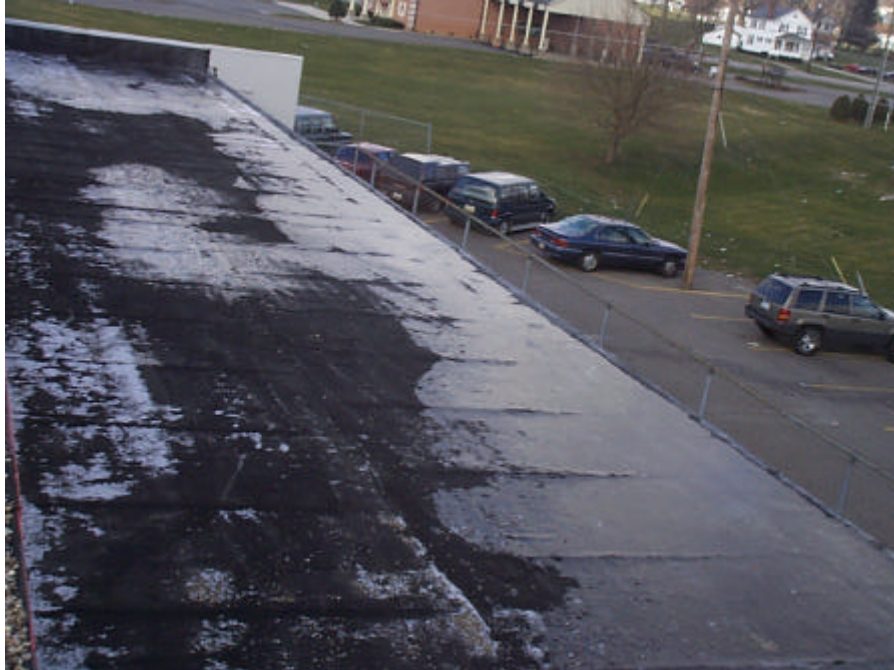
PHOTOGRAPH 5

- *Base Flashing Holes:* There were several holes in the base flashing along the west parapet wall.
- *Missing Parapet Coping:* The parapet coping was missing from the east parapet wall exposing the wood nailers and the base flashing was open at the top (Reference Photograph 17).
- *Ponded Water:* There was substantial ponding water over the majority of the north side of the roof (Reference Photograph 5).

View of north garden center roof area looking northwest. Note ponding water along north edge.

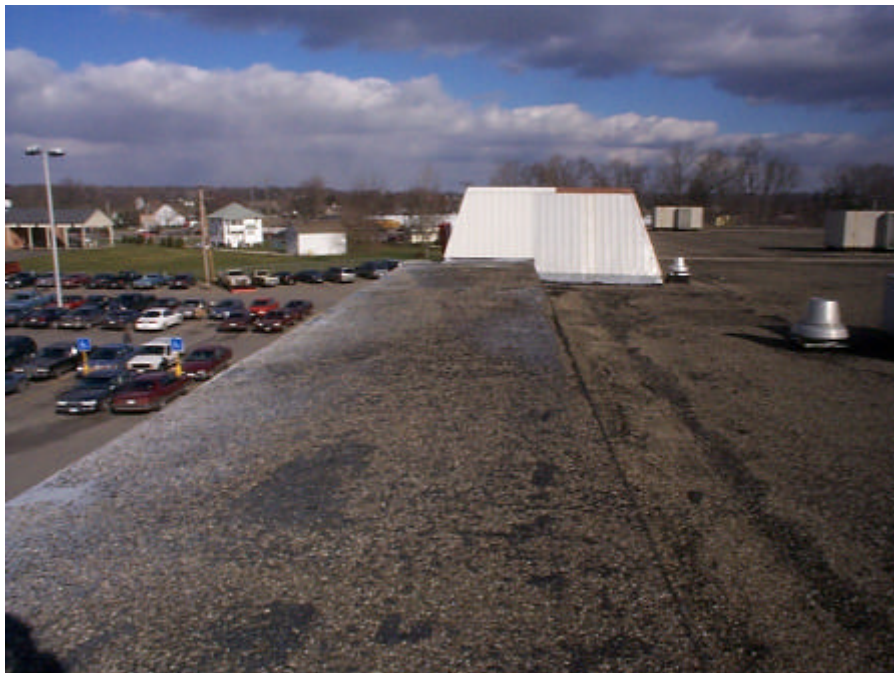
Southwest upper roof area looking north toward entrance canopy.

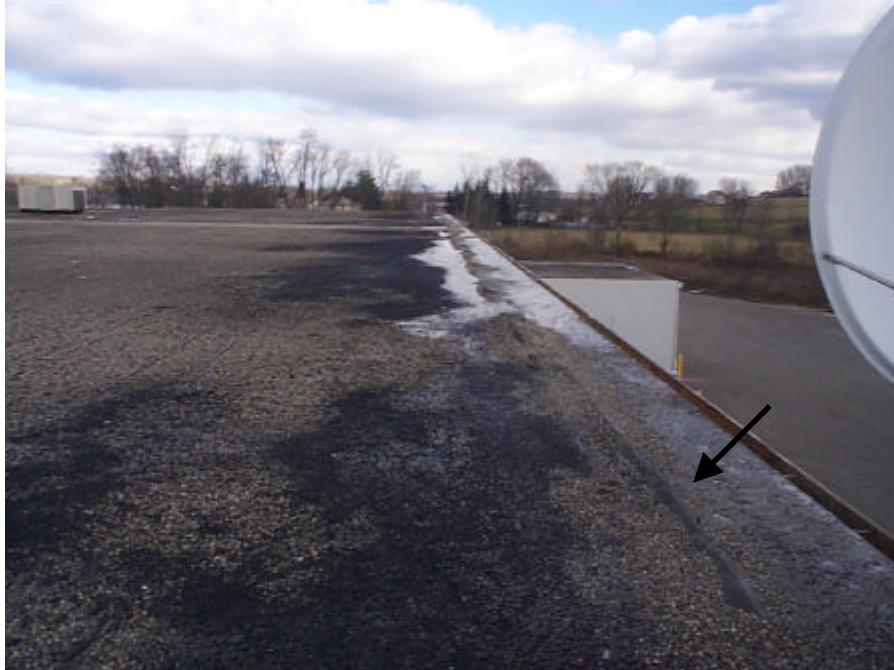
PHOTOGRAPH 7

Ponding water was noted along the majority of the east edge of the main roof and the majority of the north side of the Garden Center roof (Reference Photographs 6 and 7). Ponding water was also apparent at some repair areas (Reference Photograph 9).

Ponding water present along east edge of main roof area. Note blisters

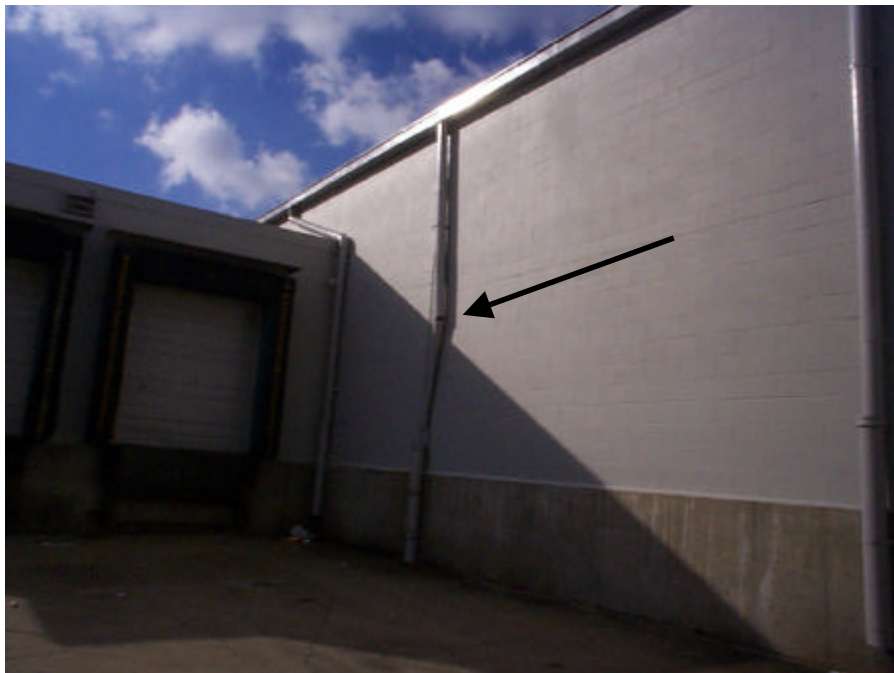
PHOTOGRAPH 8

The interiors of the gutters exhibited some rusting. One downspout on the east side of the building serving the main roof area was damaged (Reference Photograph 8).

Damaged downspout on east side of building serving the main roof area.

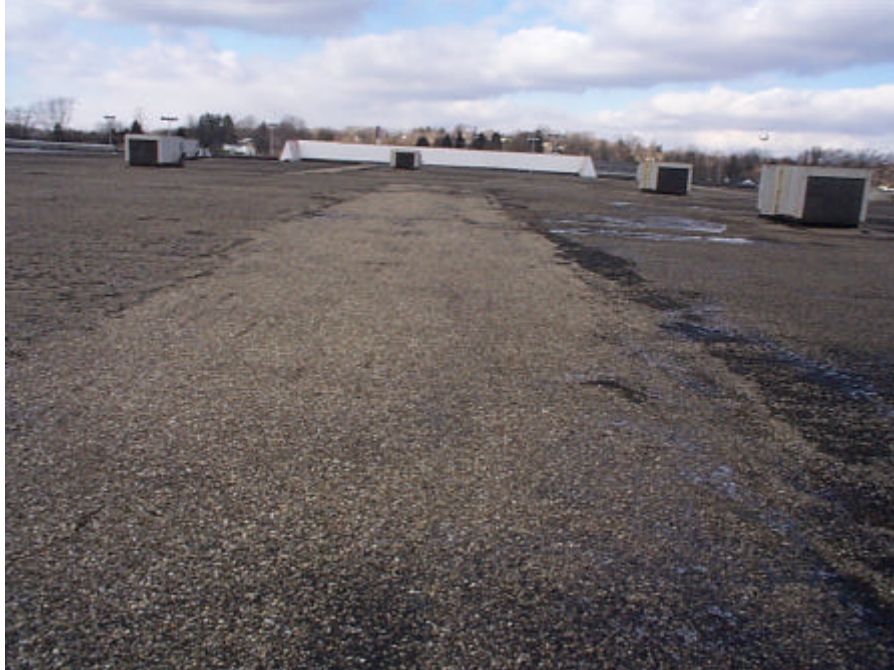
PHOTOGRAPH 9

Membrane repair apparent by aggregate surfacing color variation.

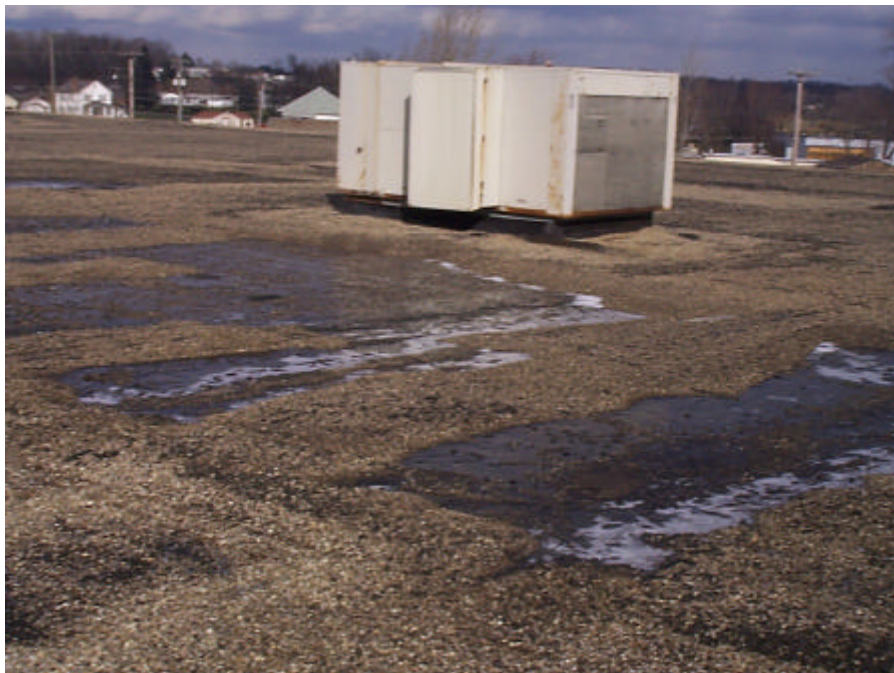
PHOTOGRAPH 10

Deteriorated seam sealant and open seam at field membrane lap. Note ponding water within repair area.

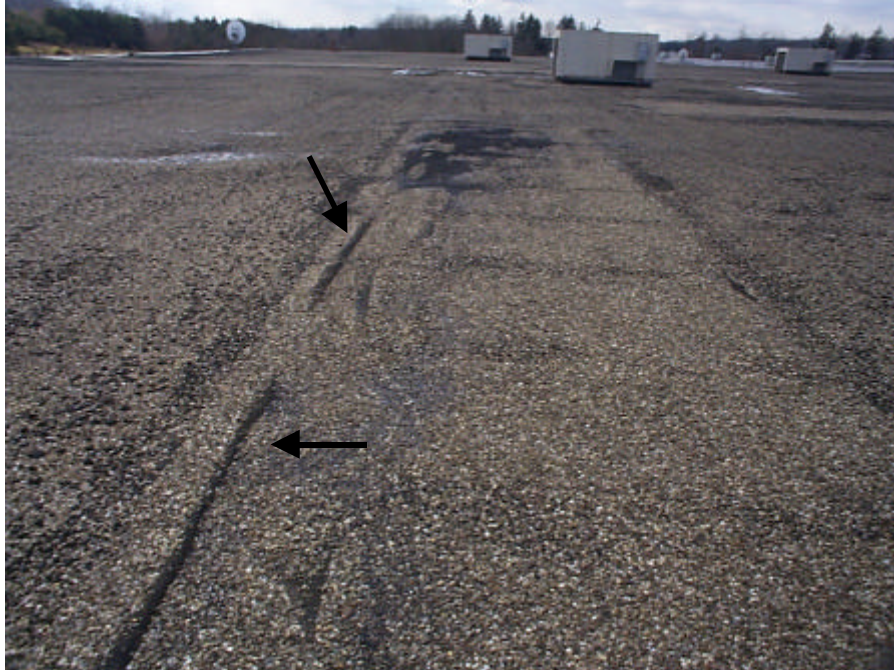
PHOTOGRAPH 11

Repair area on north side of main roof. Note blisters in membrane.

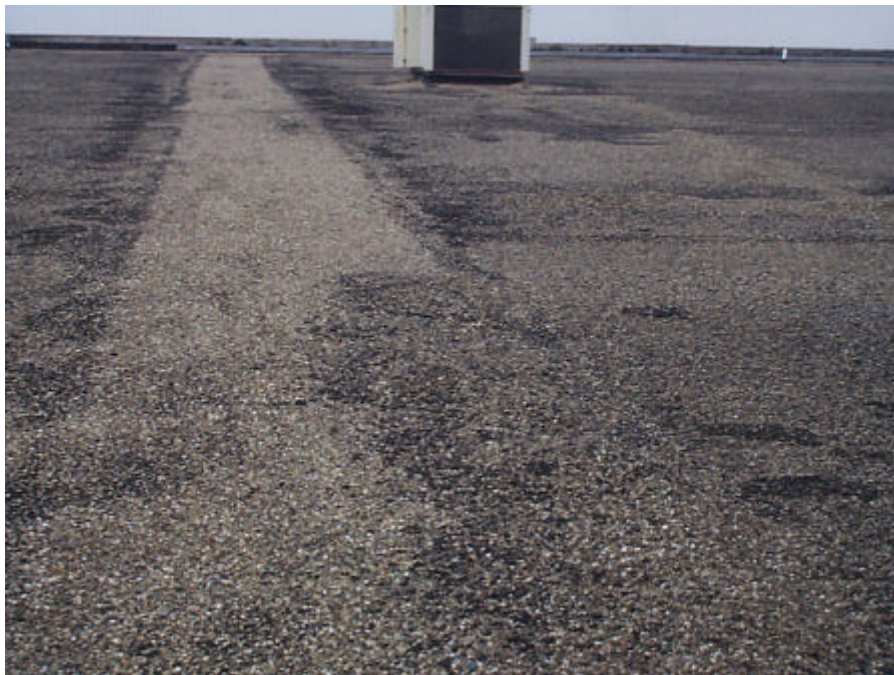
PHOTOGRAPH 12

Repair area apparent due to variation in aggregate color.

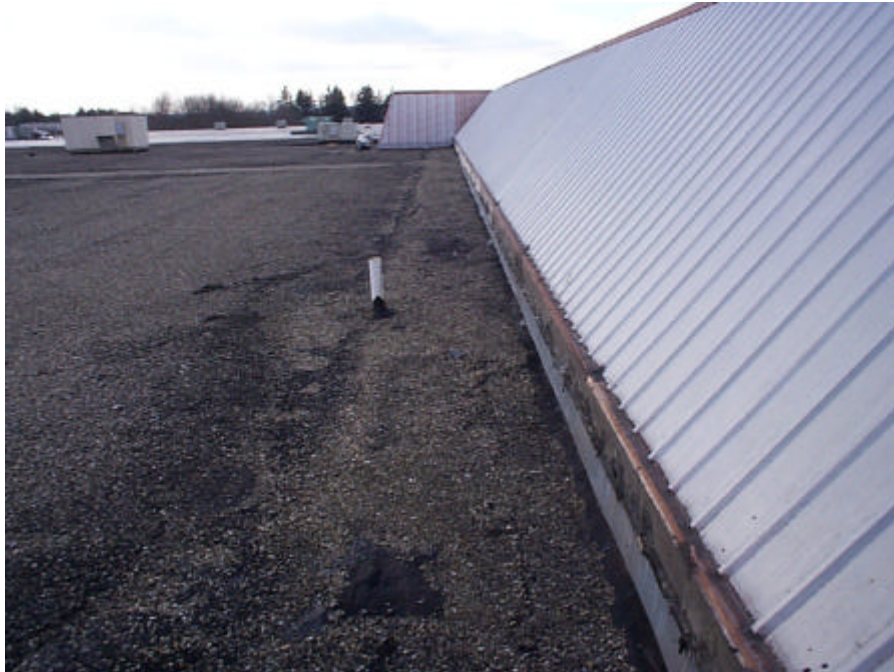
PHOTOGRAPH 15

Repairs and blisters along west (front) standing seam canopy roof.

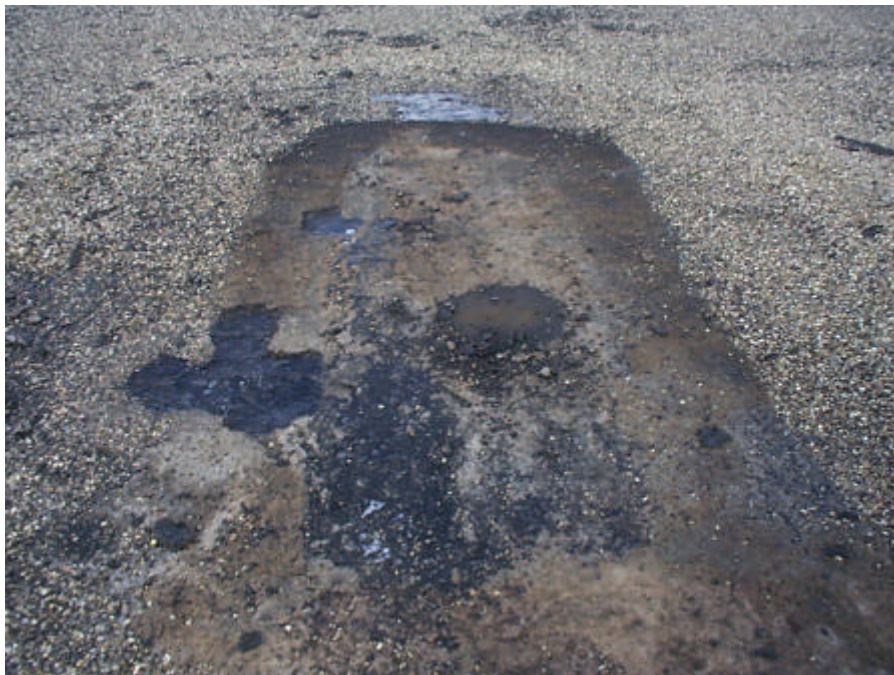
PHOTOGRAPH 16

Some repairs had been completed by application of flood coat bitumen (most likely asphalt) over the existing gravel or with roofing mastic (Reference Photograph 16).

Repair completed with roofing cement on main roof. Note blisters in repair.

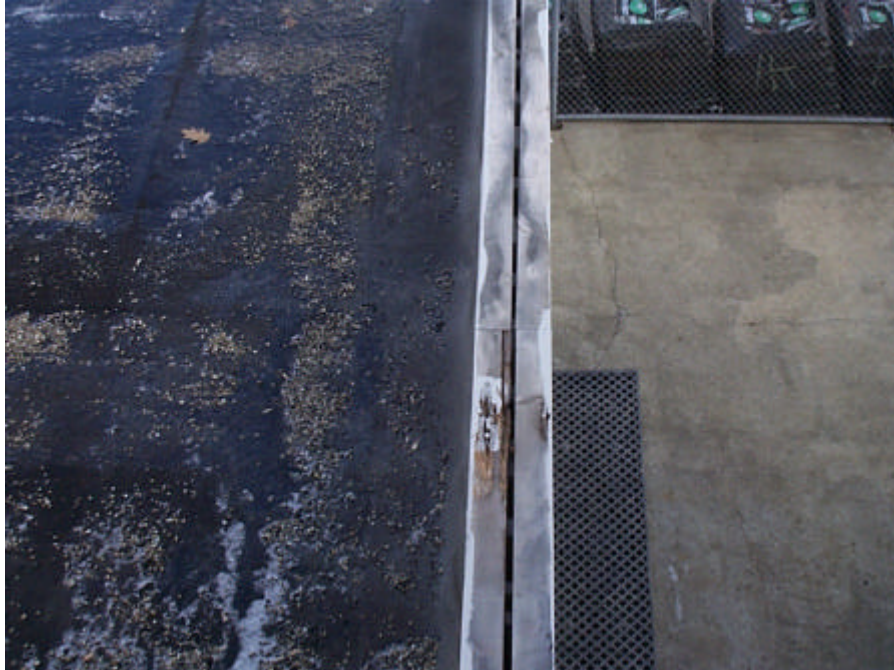
PHOTOGRAPH 17

Missing coping on east parapet wall of north Garden Center roof.

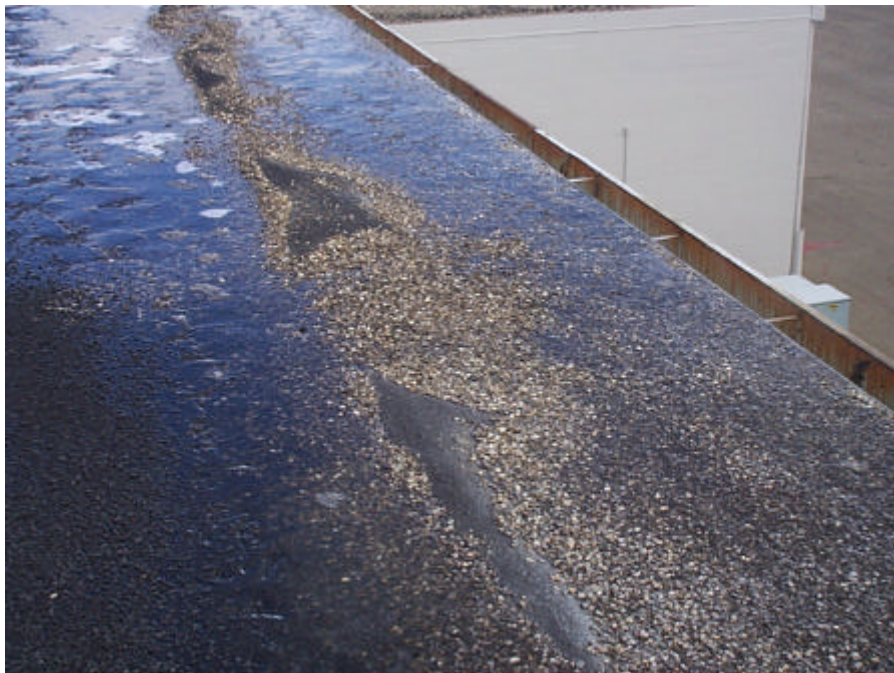
PHOTOGRAPH 18

Extensive blisters in repair along east side of main roof area (typical condition).

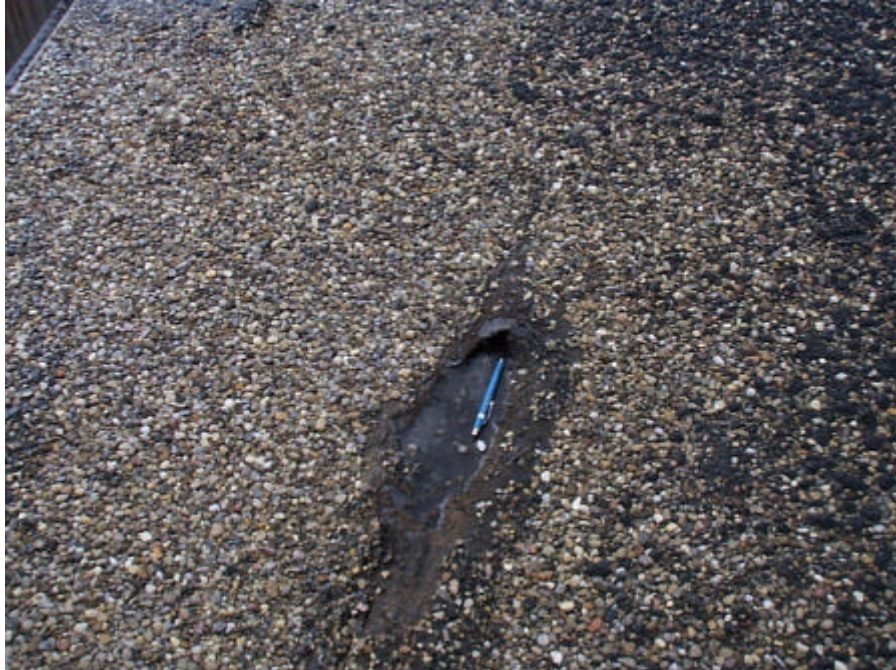
PHOTOGRAPH 19

Damaged blister in repair along east edge of main roof

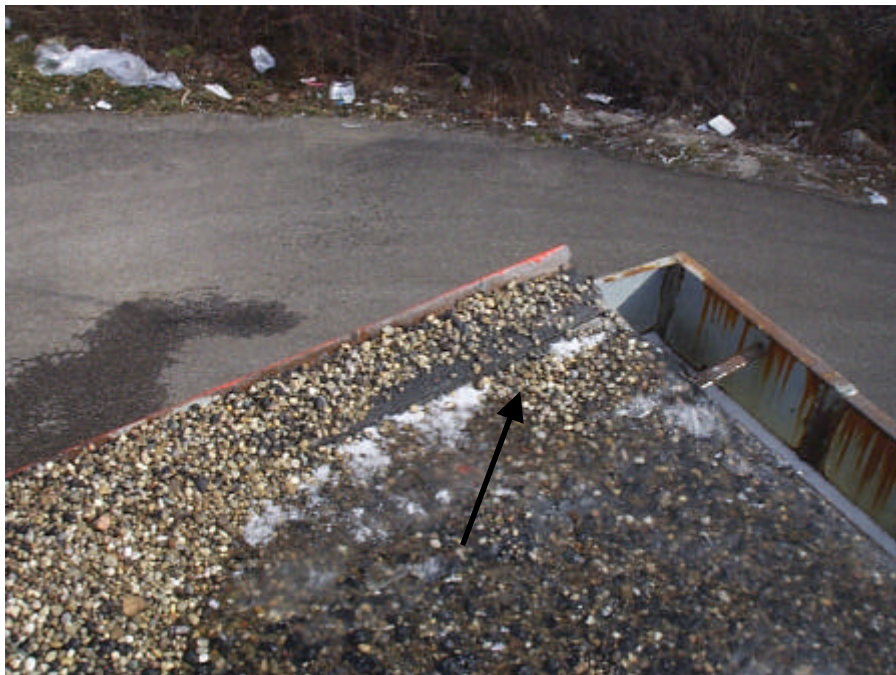
PHOTOGRAPH 20

Deteriorated strip-in plies and exposed metal edge flashing at northeast corner of main roof. Note rusted gutter.

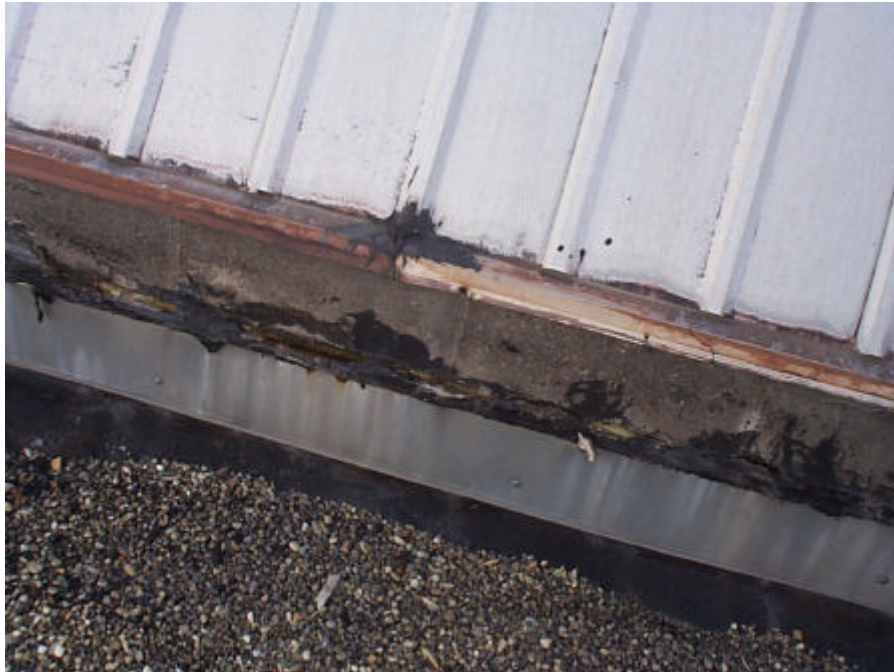
PHOTOGRAPH 21

exposed. Also inadequate base flashing and metal roof repairs have been completed with roofing cement at one location (Reference Photograph 21 and 22).

Exposed masonry wall and deteriorated sealant at counter flashing at west parapet wall.

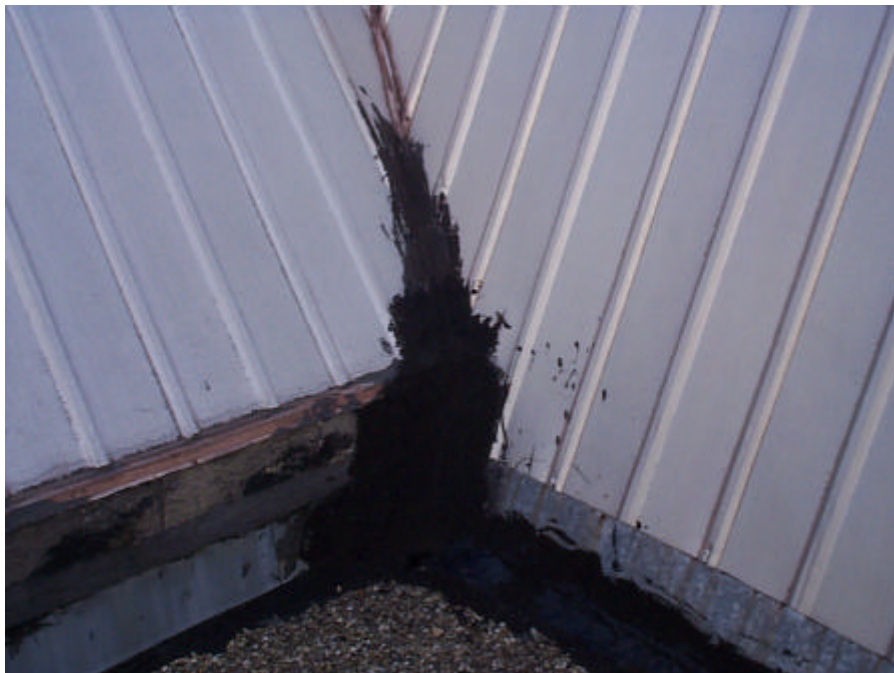
PHOTOGRAPH 22

Inadequate repairs completed with roofing cement at base flashing and standing seam metal roof at west side of building.

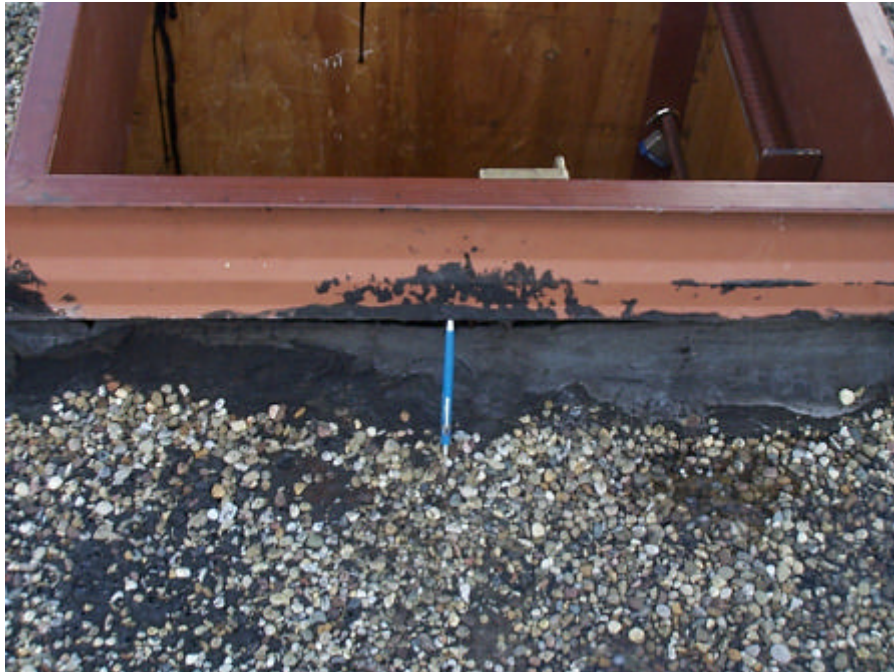
PHOTOGRAPH 23

Base flashing open at top at access hatch on main roof.

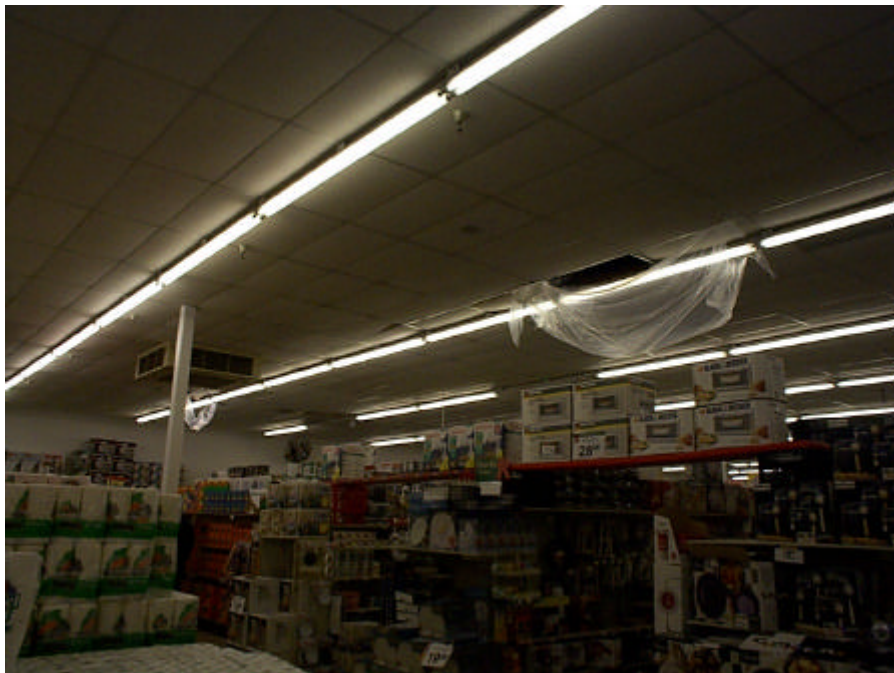
PHOTOGRAPH 24

Suspended plastic at leaks within store.
